**Flood Control Project Maintenance
Levee Inspections**
LMA District Cover Sheet
Spring 2020 Levee Inspection Results

Sacramento River West Side Levee District

Spring 2020 Levee Inspection Results

Waterway			Bank	Unit Miles
Unit No. 01 Sacramento River			Right	49.64
	Spring (March - May)	Summer (June - August)	(September - November) Fall	Winter (December - February)
Unit Maintenance Rating (Fall Only)				
Date of Inspection	3/24/2020 - 3/24/2020			
DWR Inspector	Zach Jojola			
Accompanied By	Gary Marler RD0108

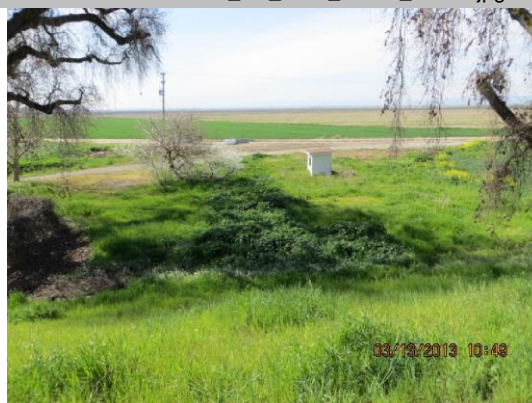
Photo 2 of 2 : UCIP_SP_2020_55864_27166.jpg

Comment Code						
Inspector Comment						
DS_ID:20237 FS_ID:55864 EP_NO: 3630 Repair Type: Non-Urgent Crossing Status: Not Found UCIP Comments: 9/30/2019 Record updated from No Action Needed to Non-Urgent. Crossing not found. Need to have CVFPB review ABO and determine current owner. (O.Yakimov - DWR UCIP) FIELD_STRUCT_DESC: *ABANDONED* [Tysdall Mound Pumping Plant] 2 of 3: 24-inch steel irrigation pipe through the levee, 5 feet below the crown. Vertical pump unit on the waterside (WS). Siphon breaker on the landside (LS). Concrete distribution box on the LS. Walkway provided to pumps. (24-inch discharge pipe authorized under Automatic Board Order (ABO) issued as Permit No. 9354, 1974 - Reclamation District No. 108). (Tysdale Mound Pumping Plant authorized under Permit No. 3630, 1961 - Reclamation District No. 108). Grouted in place. No above-ground appurtenances remain. [Additional Reference(s): DWR Levee Log, 2006, (HLM 14.53)]. FS Date: 9/30/2019 2:50:07 PM

Location of abandoned pumping plant LS.

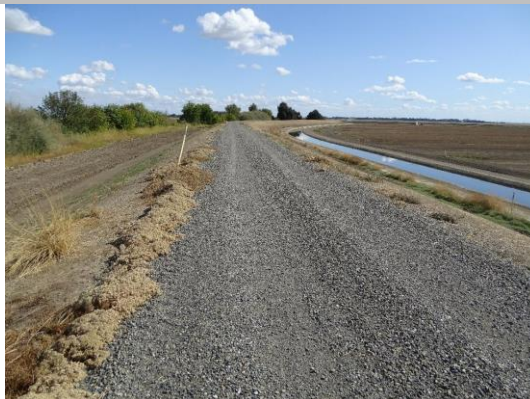
Photo 1 of 3 : UCIP_SP_2020_55882_83117.jpg

Comment Code						
Inspector Comment						
DS_ID:20432						
FS_ID:55882						
EP_NO: N/A						
Repair Type: Non-Urgent						
Crossing Status: Found						
UCIP Comments: 9/30/2019 Record remains Non-Urgent. No inspection records were available to determine status of line through the levee. Permit is not available for this crossing. (O.Yakimov - DWR UCIP)03/13/2013 Need to determine if this is a permitted crossing as it was not previously noted. Need to determine size and depth below the crown.						
FIELD_STRUCT_DESC: Gas line of an unknown material and diameter through the levee, at an unknown depth. Marker on waterside (WS) shoulder.						
FS Date: 9/30/2019 3:40:38 PM

View of levee crown at the crossing

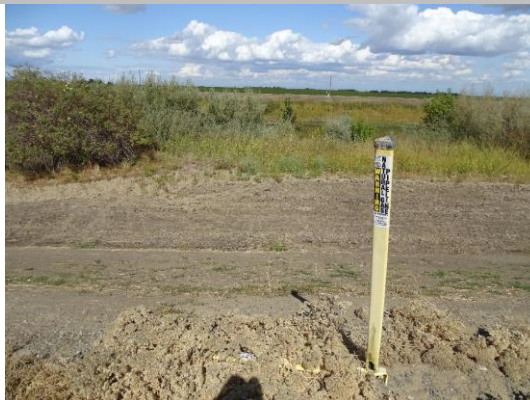
Photo 2 of 3 : UCIP_SP_2020_55882_83118.jpg

Gas line marker on WS. One at WS shoulder and another off levee toe.

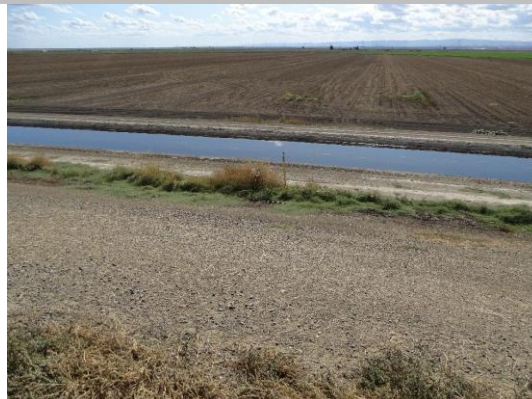
Photo 3 of 3 : UCIP_SP_2020_55882_83119.jpg

Gas line marker on LS. Two markers installed on both sides of irrigation ditch

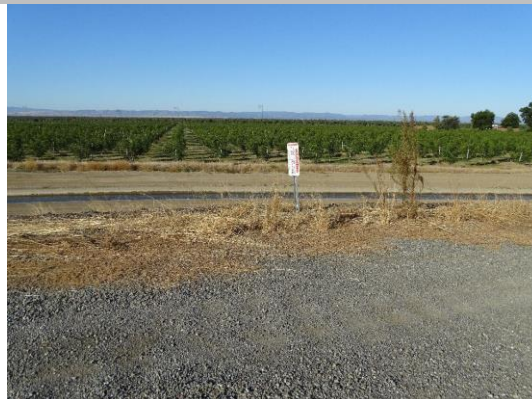
Photo 1 of 2 : UCIP_SP_2020_55890_83135.jpg

Comment Code						
Inspector Comment						
DS_ID:22957 FS_ID:55890 EP_NO: 18026 Repair Type: Non-Urgent Crossing Status: Found UCIP Comments: 10/1/2019 Record remains Non-Urgent. No as-built drawing that shows alignment found. Warning sign of buried 12kV electrical line installed on LS shoulder. (O.Yakimov - DWR UCIP)03/13/2013 Conduit needs to be located and signs installed where it crosses the levee crown. FIELD_STRUCT_DESC: Electrical conduit of an unknown material and diameter through the levee, at an unknown depth. Signage on the landside (LS) shoulder. (Permit No. 18026, 2006 - Reclamation District No. 108). FS Date: 10/1/2019 7:50:52 AM

Warning sign on LS shoulder

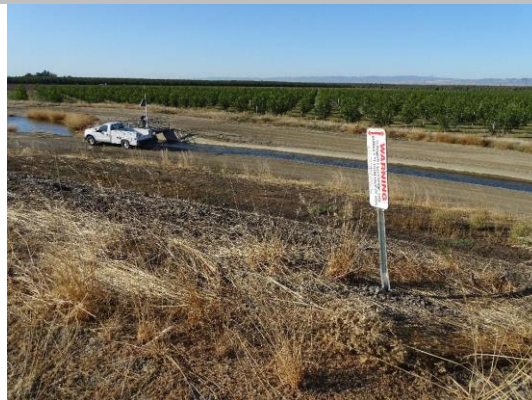
Photo 2 of 2 : UCIP_SP_2020_55890_83136.jpg

Warning sign on LS shoulder

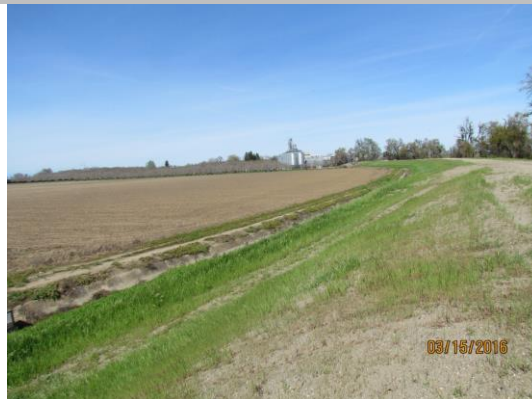
Photo 1 of 1 : SP_2020_NA0016_435_15_20200228_00003.jpg

LM Start	18.20	Rating **	M	Issue No.	15
LM End	18.46	Issue Type +	En	Location *	LS
Category	Earthen Levee			GPS Latitude/Longitude	
				Start	End
Item	Encroachments			38.946674 °	38.950263 °
				-121.837528 °	-121.837768 °
DWR ID	DWR_NA0016_01_s_2012_15				
Comment Code					
DT : Ditch					
Inspector Comment					
A concrete lined ditch runs along the toe of the levee.

View of the ditch on the landward side of the levee looking upstream.
Spring 2016.

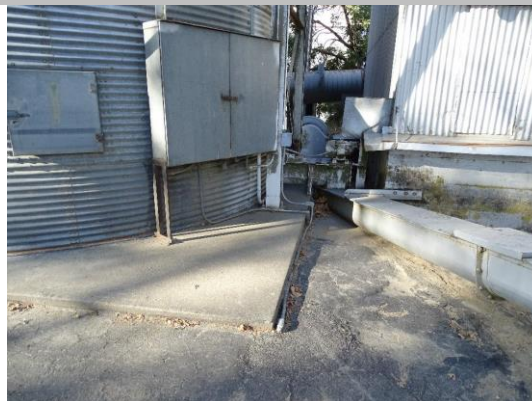
Photo 1 of 3 : UCIP_SP_2020_55894_83143.jpg

Comment Code						
Inspector Comment						
DS_ID:20240 FS_ID:55894 EP_NO: 4938B Repair Type: Non-Urgent Crossing Status: Found UCIP Comments: 10/01/2019 Crossing not in use. Property manager confirmed that a pump at riverbank has been removed and electrical puply was disconnected. Water to WS is supplied through a hose above levee crown. (O.Yakimov - DWR UCIP) FIELD_STRUCT_DESC: 1-inch galvanized iron electrical conduit through the levee, 1 foot below the crown. Conduit supplies power to 8-inch pump and pipe on the waterside (WS) slope. Pump supplies water to sprinklers on the WS slope. (Permit No. 4938-A, 1974 - Owner Unknown). [Additional References: DWR Levee Log, 2006, (HLM 18.73)] FS Date: 10/1/2019 8:17:23 AM

Electrical conduit at edge of concrete base of grainery

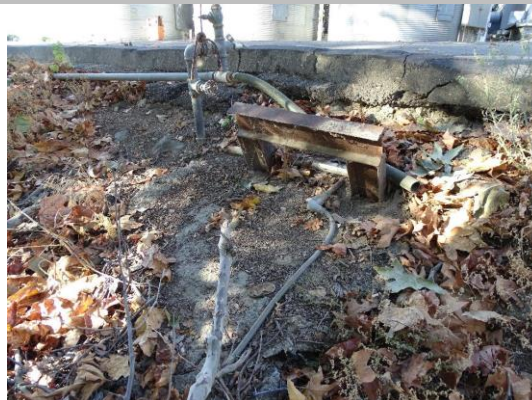
Photo 2 of 3 : UCIP_SP_2020_55894_83144.jpg

Electrical conduit at former pipe support on WS shoulder

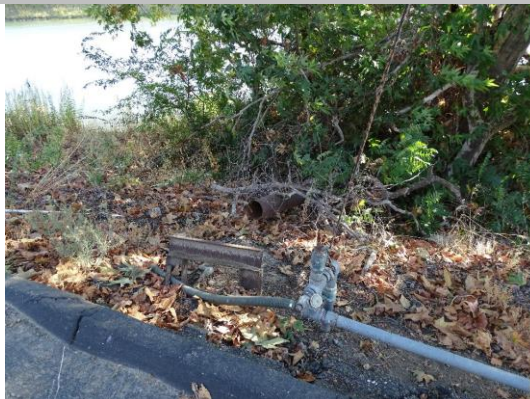
Photo 3 of 3 : UCIP_SP_2020_55894_83145.jpg

Cutoff 8-inch pipe that was used to provide water for sprinklers on WS

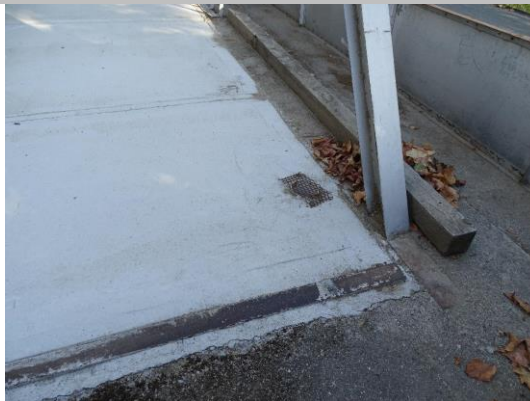
Photo 1 of 3 : UCIP_SP_2020_55895_83146.jpg

DS_ID:20241
 FS_ID:55895
 EP_NO: 4938B
 Repair Type: Non-Urgent
 Crossing Status: Found
 UCIP Comments: 10/01/2019 Steel pipe observed on WS slope. PVC pipe drains water from paved levee crown. Record updated to Non-Urgent, permit for this crossing is missing. (O.Yakimov - DWR UCIP)
 FIELD_STRUCT_DESC: 8-inch steel drainage pipe through the levee not referenced in permit 4938B, 3 feet below the crown. Pipe originates at the hinged dump platform at the grainery.
 FS Date: 10/1/2019 8:30:48 AM

Possible one of the drainage holes on levee top

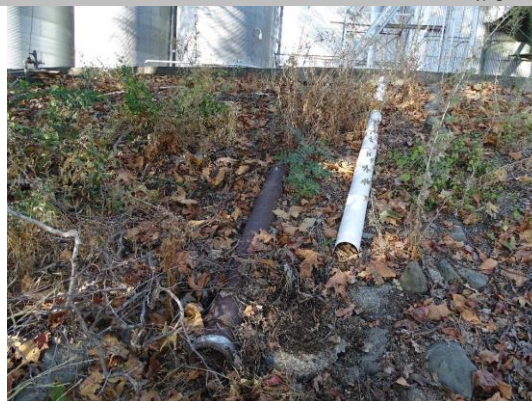
Photo 2 of 3 : UCIP_SP_2020_55895_83147.jpg

8-inch steel storm drain pipe at WSslope

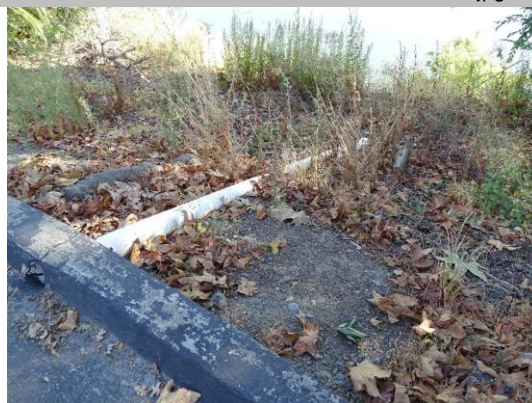
Photo 3 of 3 : UCIP_SP_2020_55895_83148.jpg

8-inch steel storm drain pipe at WSslope. View from levee crown

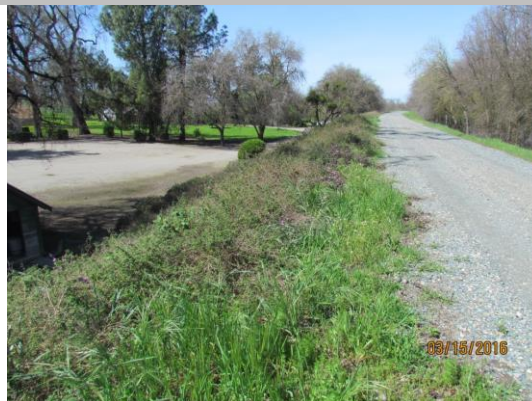
Photo 1 of 2 : SP_2020_NA0016_435_173_20200228_00058.jpg

LM Start	18.66	Rating **	M	Issue No.	173
LM End	18.70	Issue Type +	En	Location *	LS
Category	Earthen Levee			GPS Latitude/Longitude	
				Start	End
Item	Vegetation			38.952765 °	38.953219 °
				-121.839661 °	-121.840199 °
DWR ID	DWR_NA0016_01_s_2019_173				
Comment Code					
V6 : Landscaping					
Inspector Comment					
Permit number 16487. Owner needs to maintain/trim vegetation.

View of the landscaping on the landward side of the levee looking upstream. Spring 2016.

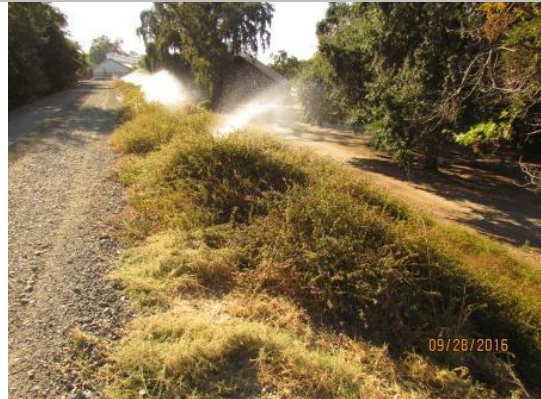
Photo 2 of 2 : SP_2020_NA0016_435_173_20200228_00059.jpg

Irrigated landscaping on landside slope of the levee reaching levee crown. Fall 2016 inspection.

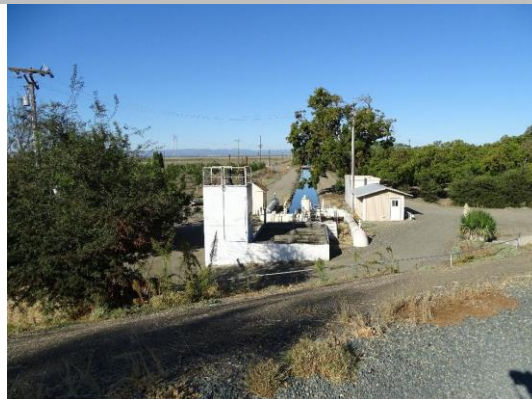
Photo 1 of 3 : UCIP_SP_2020_55896_83154.jpg

Comment Code						
Inspector Comment						
DS_ID:20386						
FS_ID:55896						
EP_NO: 1359						
Repair Type: Non-Urgent						
Crossing Status: Indicator Found						
UCIP Comments: 10/1/2019 Record updated from No Action Needed to Non-Urgent. Pipe not visible on WS. Water level in distribution box is too high to see the pipe. (O.Yakimov - DWR UCIP)						
FIELD_STRUCT_DESC: [Boyer's Bend Pumping Plant] 2 of 3: 18-inch drainage discharge pipe of an unknown material through the levee, 14 feet below the crown. Lift station is a good indicator of the location. (Permit No. 1359, 1948 - Reclamation District No. 108). [Additional Reference(s): DWR Levee Log, 2006, (HLM 19.02). USACE Sacramento O&M Manual 130, May 1960 (HLM 19.02)].						
FS Date: 10/1/2019 8:51:29 AM

Lift station on LS at levee toe

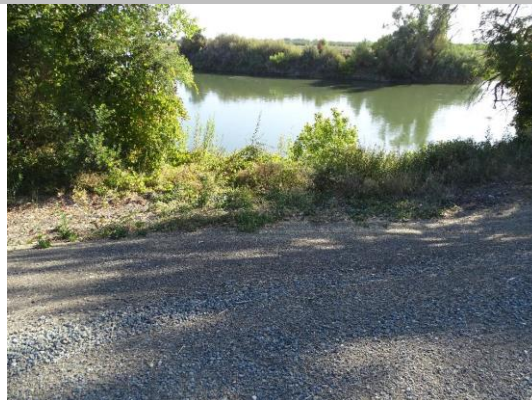
Photo 2 of 3 : UCIP_SP_2020_55896_83155.jpg

View of WS looking from levee crown

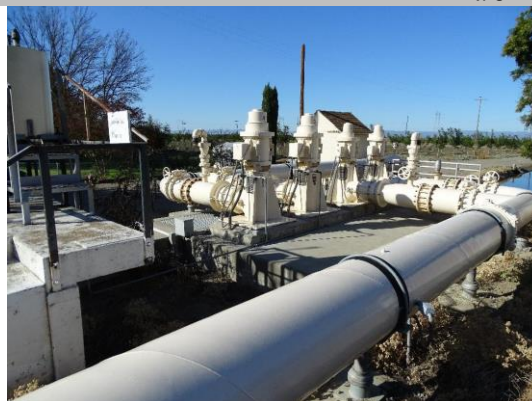
Photo 3 of 3 : UCIP_SP_2020_55896_83156.jpg

Pumps in irrigation canal on LS

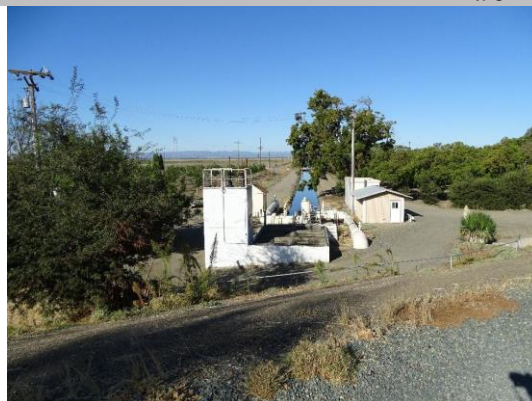
Photo 1 of 3 : UCIP_SP_2020_55898_83151.jpg

DS_ID:20387
 FS_ID:55898
 EP_NO: 1359
 Repair Type: Non-Urgent
 Crossing Status: Indicator Found
 UCIP Comments: 10/01/2019 Pipe not visible on WS. Water level in distribution box is too high to see the pipe. (O.Yakimov - DWR UCIP)
 FIELD_STRUCT_DESC: 3 of 3: 24-inch drainage discharge pipe of an unknown material through the levee, 12.5 feet below the crown. Lift station is a good indicator of the location. (Permit No. 1359, 1948 - Reclamation District No. 108). [Additional Reference(s): USACE Sacramento O&M Manual 130, May 1960 (HLM 19.02)].
 FS Date: 10/1/2019 9:09:41 AM

Lift station on LS at levee toe

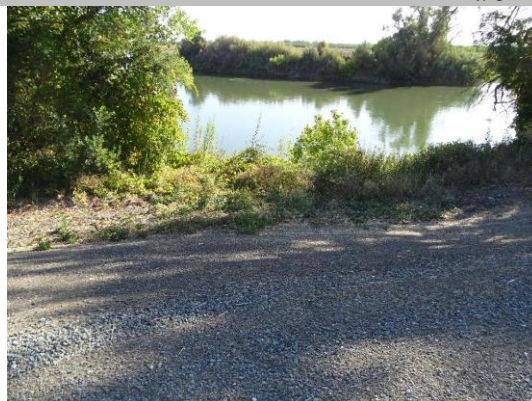
Photo 2 of 3 : UCIP_SP_2020_55898_83152.jpg

View of WS looking from levee crown

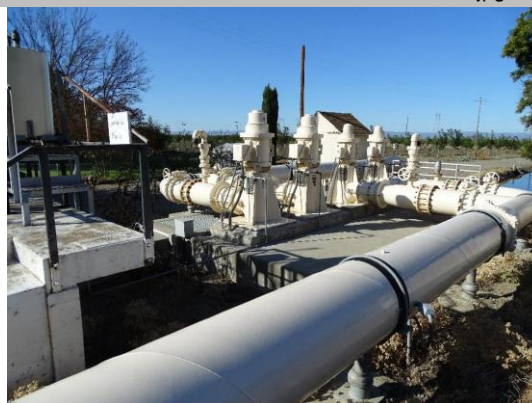
Photo 3 of 3 : UCIP_SP_2020_55898_83153.jpg

Pumps in irrigation canal on LS

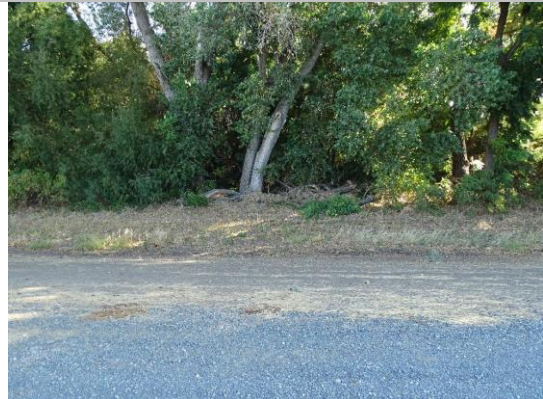
Photo 1 of 2 : UCIP_SP_2020_55897_83149.jpg

Comment Code						
Inspector Comment						
DS_ID:20303						
FS_ID:55897						
EP_NO: 9325						
Repair Type: Non-Urgent						
Crossing Status: Not Found						
UCIP Comments: 10/01/2019 Crossing not found. According to the permit pipe is located upstream of the lift station. (O.Yakimov - DWR UCIP)						
FIELD_STRUCT_DESC: *ABANDONED* 7-inch steel irrigation pipe through the levee, 8 feet below the crown. Gate valve on the waterside (WS) end. Lift station good indicator of location. (Automatic Board Order (ABO) issued as Permit No. 9325, 1974 - Leda B. Miller).						
[Additional Reference(s): DWR Levee Log, 1980. USACE Sacramento O&M Manual 130, May 1960 (HLM 19.04)].						
FS Date: 10/1/2019 8:59:03 AM

View of WS at potential crossing looking from levee crown

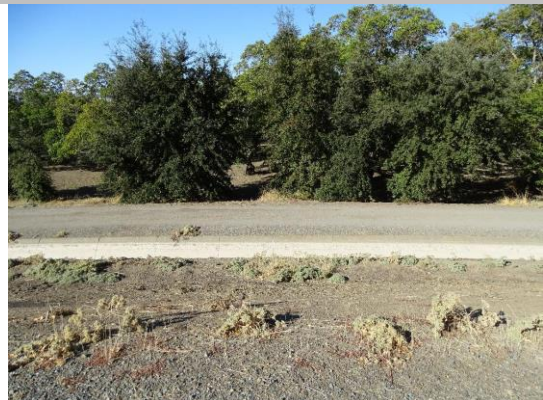
Photo 2 of 2 : UCIP_SP_2020_55897_83150.jpg

View of LS at potential crossing looking from levee crown

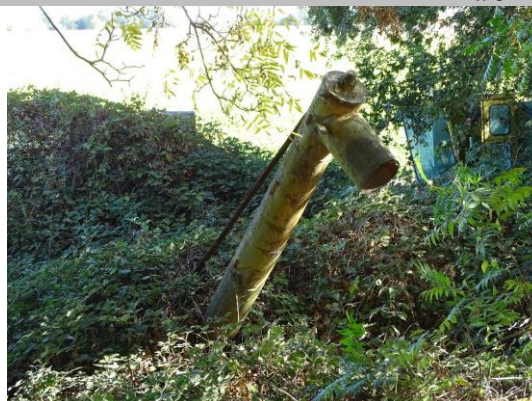
Photo 1 of 1 : UCIP_SP_2020_55903_83157.jpg

LM Start	19.12	Rating **	M	Issue No.	1591	
LM End	19.12	Issue Type +	En	Location *		
Category	Supplemental			GPS Latitude/Longitude		
				Start	End	
Item	DWR UCIP Field Study			38.957185 °	38.957185 °	
				-121.837383 °	-121.837383 °	
DWR ID	20245					
Comment Code						
Inspector Comment						
DS_ID:20245						
FS_ID:55903						
EP_NO: N/A						
Repair Type: Non-Urgent						
Crossing Status: Not Found						
UCIP Comments: 10/01/2019 Crossing not found. Residuals of a smaller diameter pipe found at this location. (O.Yakimov - DWR UCIP)						
FIELD_STRUCT_DESC: 24-inch steel irrigation pipe through the levee, 17.5 feet below the crown. Slide gate on the landside (LS) slope toe.						
[Additional Reference(s): USACE Sacramento O&M Manual 130, May 1960 (HLM 19.36)].						
FS Date: 10/1/2019 11:22:14 AM

Residuals of a smaller diameter pipe

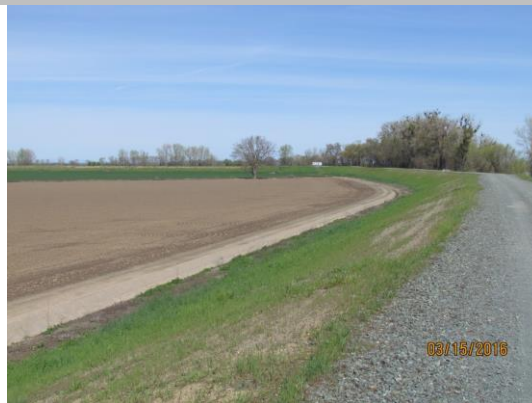
Photo 1 of 2 : SP_2020_NA0016_435_31_20200228_00010.jpg

LM Start	19.15	Rating **	M	Issue No.	31
LM End	19.61	Issue Type +	En	Location *	LS
Category	Earthen Levee			GPS Latitude/Longitude	
				Start	End
Item	Encroachments			38.957405 °	38.962648 °
				-121.836965 °	-121.834368 °
DWR ID	DWR_NA0016_01_s_2012_31				
Comment Code					
DT : Ditch					
Inspector Comment					
Concrete lined ditch up to LM 19.40. Soil ditch continues on until LM 19.61.

View of the ditch on the landward side of the levee looking upstream. Spring 2016.

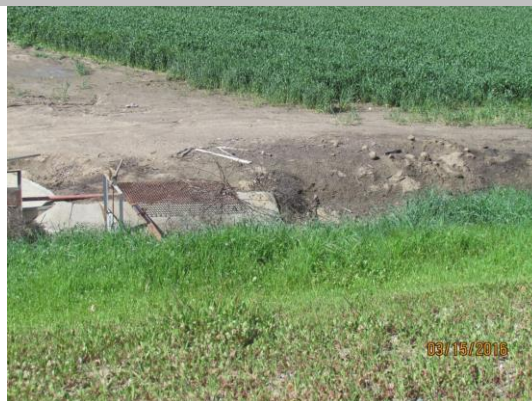
Photo 2 of 2 : SP_2020_NA0016_435_31_20200228_00011.jpg

Concrete lined ditch stops at levee mile 19.40.

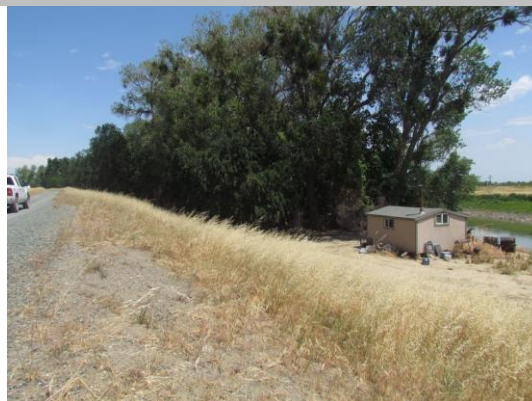
Photo 1 of 1 : SP_2020_NA0016_435_96_20200228_00029.jpg

LM Start	19.37	Rating **	M	Issue No.	96
LM End	19.37	Issue Type +	En	Location *	WS
Category	Earthen Levee			GPS Latitude/Longitude	
				Start	End
Item	Encroachments			38.959642 °	38.959642 °
				-121.834004 °	-121.834004 °
DWR ID	DWR_NA0016_01_s_2015_96				
Comment Code					
BU : Building					
Inspector Comment

View of the building on the waterward side of the levee looking upstream. Spring 2015.

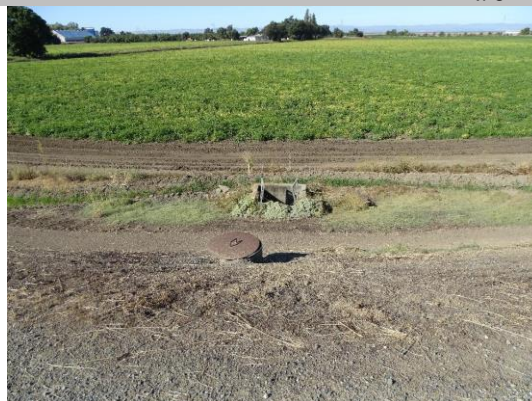
Photo 1 of 3 : UCIP_SP_2020_55904_83158.jpg

Comment Code						
Inspector Comment						
DS_ID:20246 FS_ID:55904 EP_NO: 1507 Repair Type: Non-Urgent Crossing Status: Found UCIP Comments: 10/01/2019 Record remains Non-Urgent. Crossing not in use. Sediment and debris observed inside of the pipe and concrete distribution box on LS. (O.Yakimov - DWR UCIP)03/13/2013 Pipe appears abandoned. Needs to be abandoned properly. (W. Wylie - DWR UCIP) FIELD_STRUCT_DESC: 14-inch steel irrigation pipe through the levee, 8.4 feet below the crown. Gate valve on the waterside (WS). Siphon breaker inside a 24-inch corrugated metal riser unit on the landside (LS) slope. Concrete distribution box inside an irrigation ditch on the LS toe. (14-inch pipe authorized under permit No. 1507, 1950 - Morgan Miller Jr. PN 818). [Additional Reference(s): DWR Levee Log, 2006, (HLM 19.74). USACE Sacramento O&M Manual 130, May 1960 (HLM 19.74 listed as 14-inch pipe with gate on WS)]. FS Date: 10/1/2019 11:27:39 AM

CMP riser on shoulder and concrete distribution box at LS toe

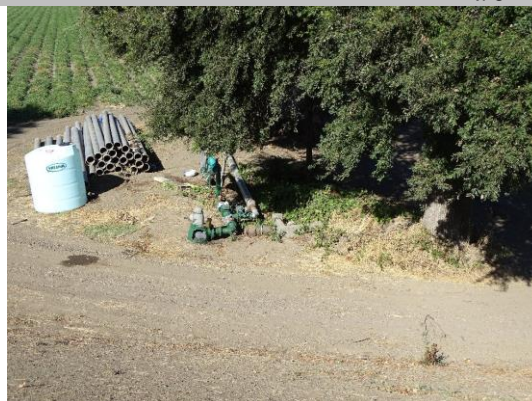
Photo 1 of 3 : UCIP_SP_2020_55905_83163.jpg

DS_ID:20336
 FS_ID:55905
 EP_NO: N/A
 Repair Type: Non-Urgent
 Crossing Status: Not Found
 UCIP Comments: 10/01/2019 Crossing not found. A well and concrete box on LS are not connected with this crossing. (O.Yakimov - DWR UCIP)
 FIELD_STRUCT_DESC: 6-inch irrigation pipe of an unknown material through the levee, 5 feet below the crown. Pump on the waterside (WS). [Additional Reference(s): USACE Sacramento O&M Manual 130, May 1960 (HLM 20.25)].
 FS Date: 10/1/2019 11:36:17 AM

A well and concrete box on LS don't belong to this crossing

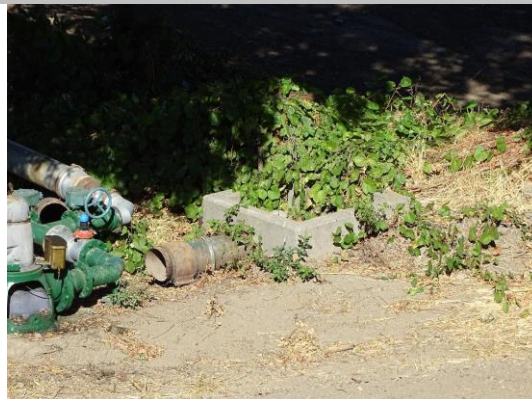
Photo 2 of 3 : UCIP_SP_2020_55905_83164.jpg

A well and concrete box

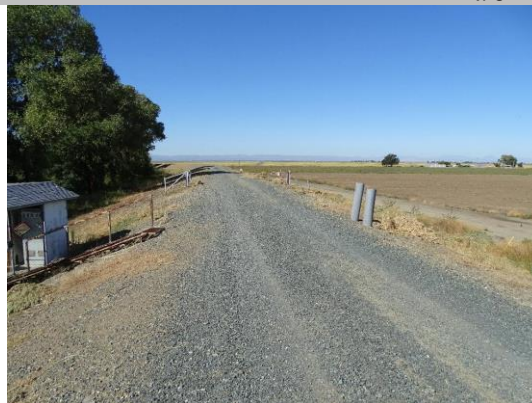
Photo 1 of 3 : UCIP_SP_2020_55909_83174.jpg

Comment Code						
Inspector Comment						
DS_ID:20368 FS_ID:55909 EP_NO: 2407 Repair Type: Non-Urgent Crossing Status: Found UCIP Comments: 10/01/2019 Crossing looks abandoned. Pipe is capped on WS slope. (O.Yakimov - DWR UCIP) FIELD_STRUCT_DESC: 2 of 2: 18-inch steel irrigation pipe through the levee, 4 feet below the crown. Two slant pumps mounted on a steel pipe structure on the waterside (WS) berm. Siphon breakers on the landside (LS) slope inside a steel riser unit. Distribution box on the LS. Flow meter inside a 2-foot corrugated metal riser unit at the WS toe. (Permit No. 2407, 1956 - Reclamation District No. 108). [Additional Reference(s): DWR Levee Log, 2006. USACE Sacramento O&M Manual 130, May 1960 (HLM 22.36)]. FS Date: 10/1/2019 1:33:20 PM

View of levee crown at the crossing

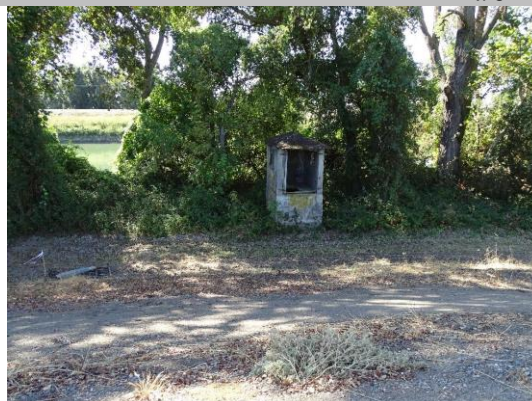
Photo 2 of 3 : UCIP_SP_2020_55910_83182.jpg

Concrete pumphouse on WS berm

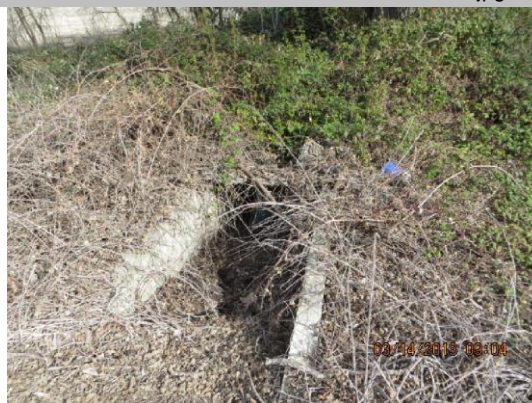
Photo 3 of 3 : UCIP_SP_2020_55910_17489.jpg

Concrete box on LS toe.

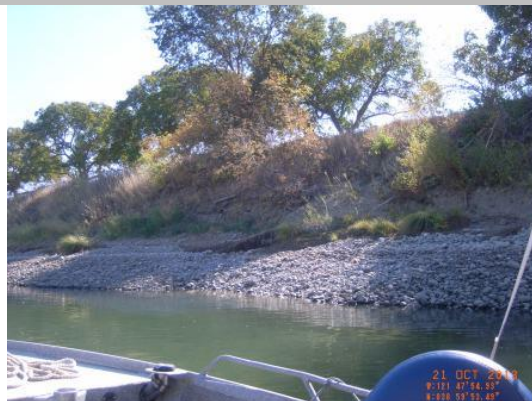
Photo 1 of 1 : SP_2020_NA0016_435_86_20200228_00020.jpg

LM Start	23.55	Rating **	A/W	Issue No.	86
LM End	23.65	Issue Type +	Ma	Location *	WS
Category	Supplemental			GPS Latitude/Longitude	
				Start	End
Item	2017 USACE Erosion Survey			38.997696 °	38.998336 °
				-121.797584 °	-121.799298 °
DWR ID	DWR_NA0016_01_f_2018_86				
Comment Code					
Inspector Comment					
2017 Site ID: SAC 115.9 R					
Status: Eroding					
2017 Field Notes: No observed change.					
Site History: 2008 - Slippage of cobbles off hard underlying toe material. 2011 - Minor slumping site. 2012 - Failing cobble site, site extended upstream. 2016 - New erosion pockets.

USACE 2013 Photo #1

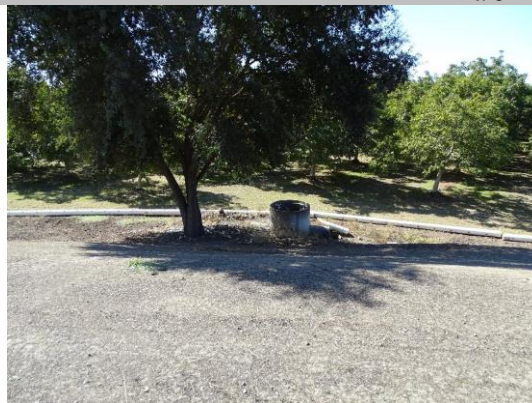
Photo 1 of 3 : UCIP_SP_2020_55911_83183.jpg

Comment Code						
Inspector Comment						
DS_ID:20249 FS_ID:55911 EP_NO: 9374 Repair Type: Non-Urgent Crossing Status: Found UCIP Comments: 10/01/2019 Crossing looks abandoned. On WS slope in CMP riser slide gate stem is bent putting slide gate in non-operational condition. Slide gate is currently in closed position. (O.Yakimov - DWR UCIP)03/14/2013 Appears abandoned. Pipe should be properly abandoned. FIELD_STRUCT_DESC: 1 of 4: 36-inch corrugated metal irrigation pipe through the levee, 20 feet below the crown. One corrugated metal cutoff wall installed by the United States Army Corp of Engineers, 1955. Slide gate inside a 36-inch corrugated metal riser unit on the waterside (WS) slope. Pump on the WS bank. Concrete standpipe on the landside (LS) toe. (Automatic Board Order (ABO) issued as Permit No. 9374, 1974 - Richard H. Moore). [Additional Reference(s): USACE Sacramento O&M Manual 130, May 1960 (HLM 24.03)]. FS Date: 10/1/2019 1:45:53 PM

Concrete standpipe on LS toe

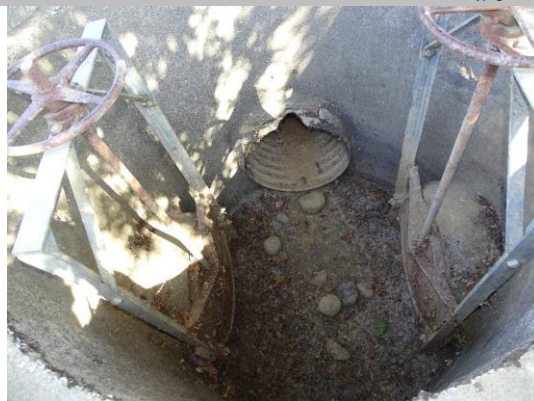
Photo 2 of 3 : UCIP_SP_2020_55911_83184.jpg

View inside of concrete standpipe on LS toe

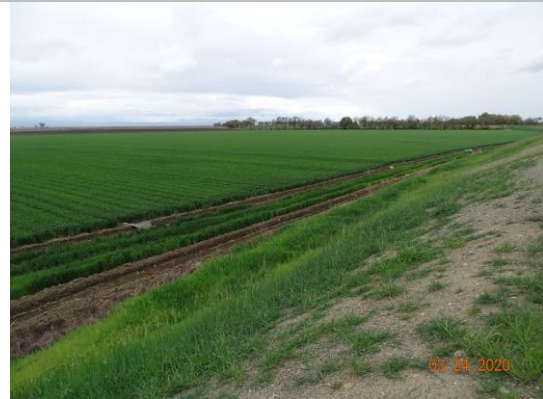
Photo 1 of 1 : SP_2020_NA0016_435_215_20200325_00395.jpg

LM Start	23.87	Rating **	M	Issue No.	215
LM End	23.93	Issue Type +	En	Location *	LS
Category	Earthen Levee			GPS Latitude/Longitude	
				Start	End
Item	Encroachments			38.999693 °	39.000374 °
				-121.802672 °	-121.803418 °
DWR ID	DWR_NA0016_01_s_2020_215				
Comment Code					
DT : Ditch					
Inspector Comment					
Irrigation ditch at the landside toe.

View of ditch at the landside toe. Spring 2020.

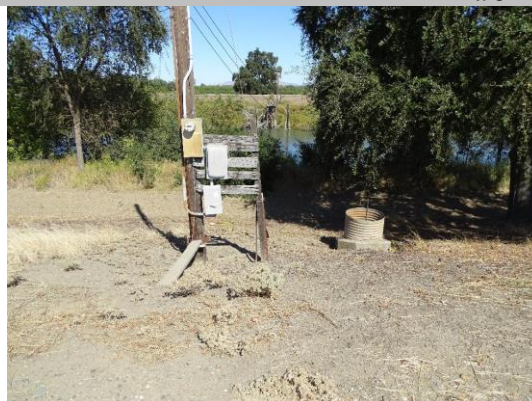
Photo 1 of 3 : UCIP_SP_2020_55914_83194.jpg

Comment Code						
Inspector Comment						
DS_ID:20251 FS_ID:55914 EP_NO: 9328 Repair Type: Non-Urgent Crossing Status: Found UCIP Comments: 10/01/2019 Observed pipe running. No leaks detected. (O.Yakimov - DWR UCIP)03/14/2013 Appears abandoned. Needs to be abandoned properly. FIELD_STRUCT_DESC: 24-inch corrugated metal irrigation pipe through the levee, 20 feet below the crown. Slide gate inside a 36-inch corrugated metal riser unit on the waterside (WS) slope. 7-foot by 9-foot distribution box at the toe of the landside (LS) slope. (Automatic Board Order (ABO) issued as Permit No. 9328, 1974 - Wayne A. Hine). [Additional Reference(s): DWR Levee Log, 2006. USACE Sacramento O&M Manual 130, May 1960 (HLM 25.02)]. FS Date: 10/1/2019 2:28:31 PM

View of WS looking from levee crown

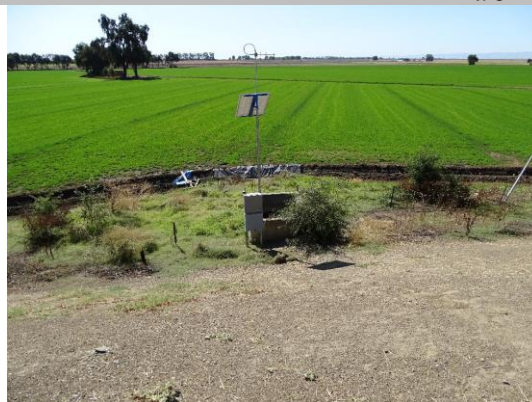
Photo 2 of 3 : UCIP_SP_2020_55914_83195.jpg

View of LS looking from levee crown

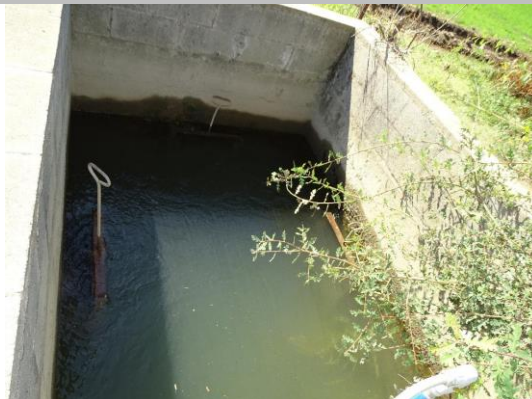
Photo 3 of 3 : UCIP_SP_2020_55914_83196.jpg

7-foot by 9-foot distribution box at LS toe

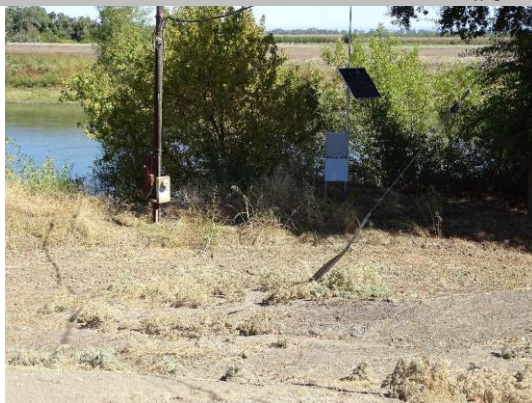
Photo 1 of 3 : UCIP_SP_2020_55915_83200.jpg

View of WS looking from levee crown

Comment Code					
Inspector Comment					
DS_ID:20339 FS_ID:55915 EP_NO: 9330 Repair Type: Non-Urgent Crossing Status: Found UCIP Comments: 10/01/2019 No issues recorded during inspection. (O.Yakimov - DWR UCIP)09/23/2016 - pump in operation during field visit. Gate valve was located on the WS near the powerpole. Visible pipe is a 6 inch on both the LS and WS. 10 inch may be buried within the levee prism, if present. (T. Hatch/UCIP) 09/01/2016 sink hole on WS berm appears to have been repaired. WS pump platform appears unchanged from previous inspection. pipe discharges into canal on LS toe and appears to be encased in concrete under tree on LS toe. (T. Hatch/UCIP) 03/14/2013 Possible sink hole over pipe alignment on WS berm at rivers edge. general condition of pipe and appurtenances in disrepair. (W. Wylie/UCIP) FIELD_STRUCT_DESC: 10-inch steel irrigation pipe through the levee, 12.3 feet below the crown. 6-inch pipe discharges into a 10-inch pipe on the waterside (WS). Portable pump and gate valve on the WS. Power pole and anchor on the WS shoulder and toe. (Automatic Board Order (ABO) issued as Permit No. 9330, 1974 - Paul Locvich). [Additional Reference(s): DWR Levee Log, 2006. USACE Sacramento O&M Manual 130, May 1960 (HLM 25.31)]. FS Date: 10/1/2019 2:40:26 PM

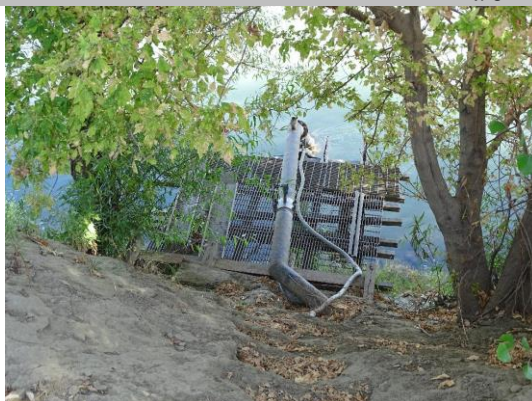
Photo 2 of 3 : UCIP_SP_2020_55915_83201.jpg

Pump platform and pipe with submersible pump on riverbank

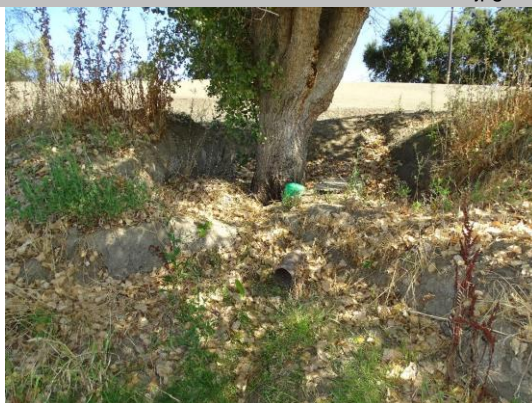
Photo 3 of 3 : UCIP_SP_2020_55915_83202.jpg

6-inch pipe at LS toe

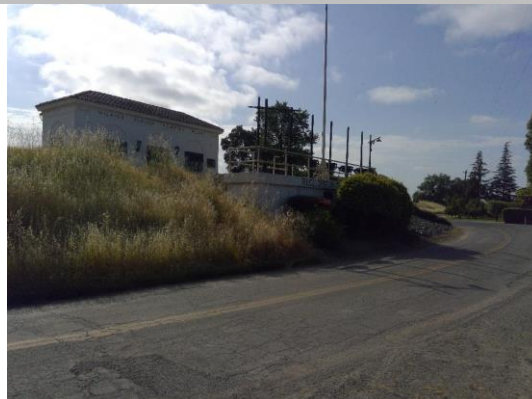
Photo 1 of 3 : UCIP_SP_2020_53940_79167.jpg

Comment Code					
Inspector Comment					
DS_ID:20252 FS_ID:53940 EP_NO: 9354 Repair Type: Non-Urgent Crossing Status: Found UCIP Comments: 05/06/2019 No issues recorded during inspection. (O.Yakimov - DWR UCIP) 09/21/2017 Reclamation District No. 108 diverts irrigation water from the Sacramento River using the Wilkins Slough Pumping Plant. (DWR UCIP - O. Magana) FIELD_STRUCT_DESC: [Wilkins Slough Pumping Plant] 1 of 6: 5-foot by 5-foot reinforced concrete irrigation culvert through the levee, 40 feet below the crown. Control gates on the landside (LS) and waterside (WS) shoulder. Pump on the WS berm. (six 5-foot by 5-foot culverts [HLM 25.88] authorized under Automatic Board Order (ABO) issued as Permit No. 9354, 1974 - Reclamation District No. 108; plant was upgraded with new fish latter in 2005; positive barrier fish screens authorized under Permit No. 16748, 1997 - Reclamation District No. 108 [RD0108]; other related Permit Nos. include 1359 and 1534). [Additional Reference(s): DWR Levee Log, 2006. USACE Sacramento O&M Manual 130, May 1960 (HLM 25.88)]. FS Date: 5/6/2019 9:18:12 AM

View of pumping station on levee crown.

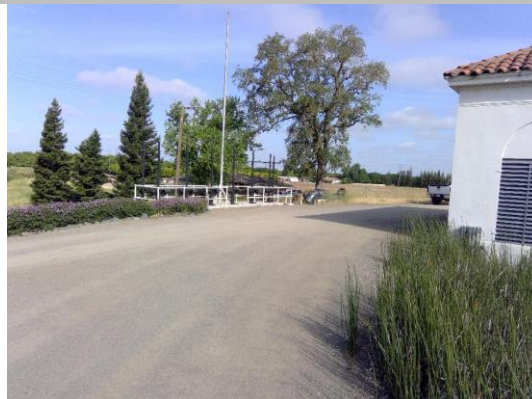
Photo 2 of 3 : UCIP_SP_2020_53967_79169.jpg

View of slide gate on LS shoulder. Six pipes are crossing levee.

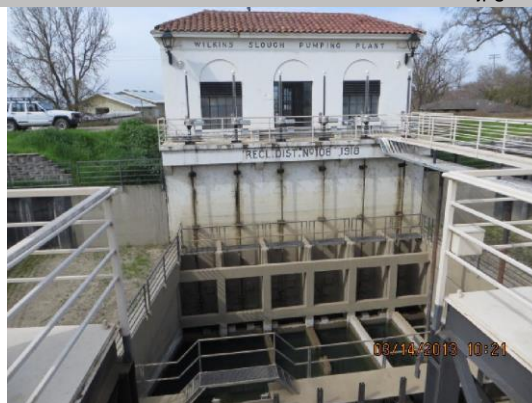
Photo 3 of 3 : UCIP_SP_2020_53967_17530.jpg

Pumphouse on WS shoulder

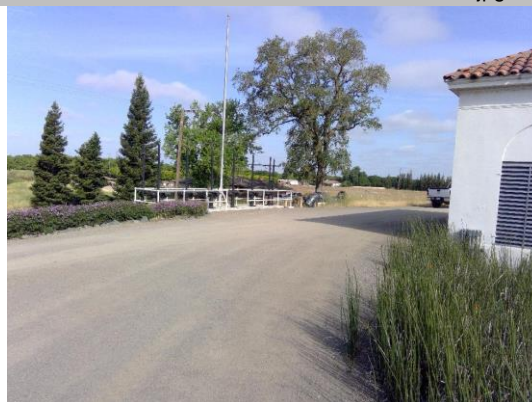
Photo 2 of 3 : UCIP_SP_2020_53968_79171.jpg

View of slide gate on LS shoulder. Six pipes are crossing levee.

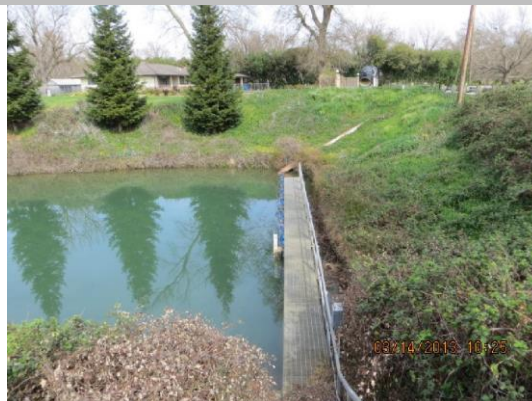
Photo 3 of 3 : UCIP_SP_2020_53969_17514.jpg

Walkway and gates along LS toe.

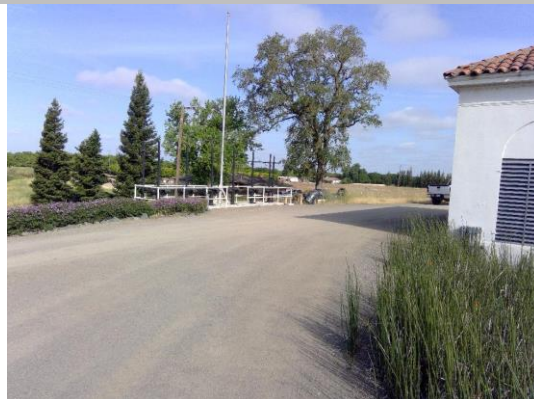
Photo 2 of 3 : UCIP_SP_2020_53971_79177.jpg

View of slide gate on LS shoulder. Six pipes are crossing levee.

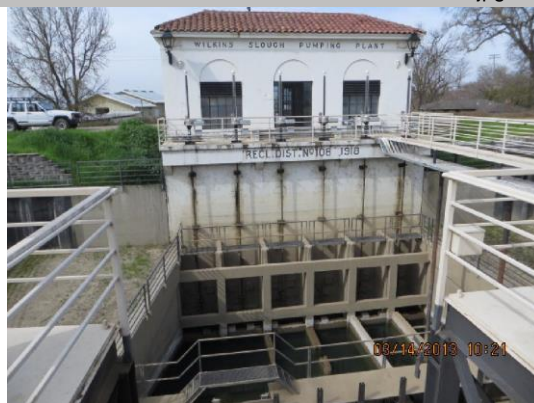
Photo 3 of 3 : UCIP_SP_2020_53971_17513.jpg

Pumphouse on WS shoulder.

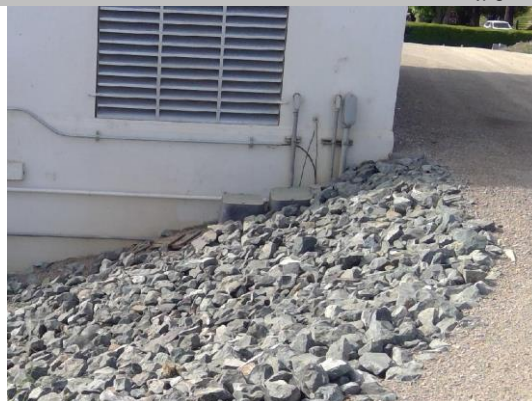
Photo 1 of 2 : UCIP_SP_2020_53972_79178.jpg

LM Start	25.57	Rating **	M	Issue No.	1607	
LM End	25.57	Issue Type +	En	Location *		
Category	Supplemental			GPS Latitude/Longitude		
				Start	End	
Item	DWR UCIP Field Study			39.012428 °	39.012428 °	
				-121.827907 °	-121.827907 °	
DWR ID	22958					
Comment Code						
Inspector Comment						
DS_ID:22958 FS_ID:53972 EP_NO: N/A Repair Type: Non-Urgent Crossing Status: Found UCIP Comments: 05/06/2019 Permit is not available for this crossing. (O.Yakimov - DWR UCIP) FIELD_STRUCT_DESC: 1.5-inch polyvinyl chloride irrigation line through the levee, 2 feet below the crown. Distribution manifold at the corner of building on waterside (WS) shoulder. FS Date: 5/6/2019 2:20:57 PM

View of water distribution boxes on WS shoulder.

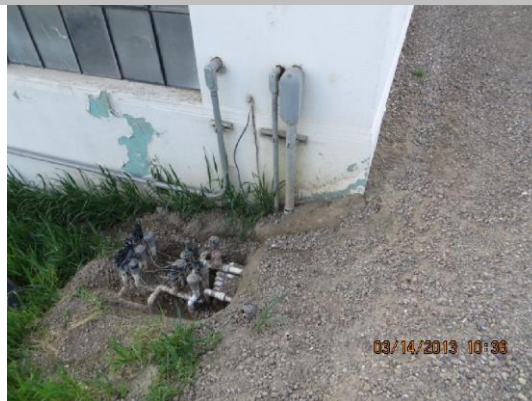
Photo 2 of 2 : UCIP_SP_2020_53972_18721.jpg

Waterline and distribution manifold at WS shoulder/corner of pumphouse.

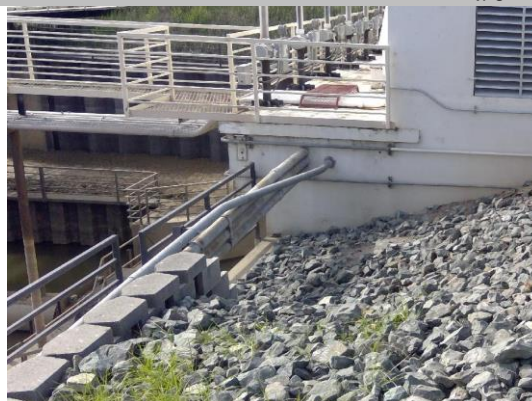
Photo 1 of 3 : UCIP_SP_2020_53973_79179.jpg

LM Start	25.58	Rating **	M	Issue No.	1608	
LM End	25.58	Issue Type +	En	Location *		
Category	Supplemental			GPS Latitude/Longitude		
				Start	End	
Item	DWR UCIP Field Study			39.012562 °	39.012562 °	
				-121.827853 °	-121.827853 °	
DWR ID	22960					
Comment Code						
Inspector Comment						
DS_ID:22960 FS_ID:53973 EP_NO: N/A Repair Type: Non-Urgent Crossing Status: Found UCIP Comments: 05/06/2019 No issues recorded during inspection. (O.Yakimov - DWR UCIP) FIELD_STRUCT_DESC: 1 of 4: 4-inch galvanized iron electrical conduit through the levee, 3 feet below the crown. Pipe runs from an electric vault on the landside (LS) shoulder to a building on the waterside (WS) shoulder. FS Date: 5/6/2019 2:44:19 PM

Closer view of conduits coming out of building

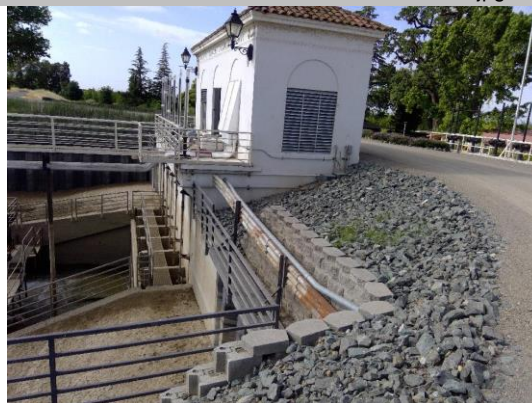
Photo 2 of 3 : UCIP_SP_2020_53973_79180.jpg

Four conduits crossing the levee. View of WS slope

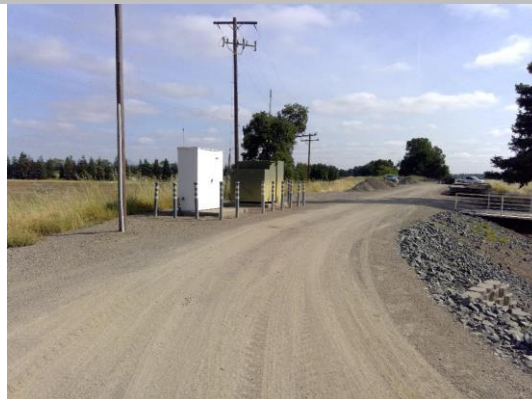
Photo 3 of 3 : UCIP_SP_2020_53973_79182.jpg

Top of Levee with electrical vaults on LS shoulder

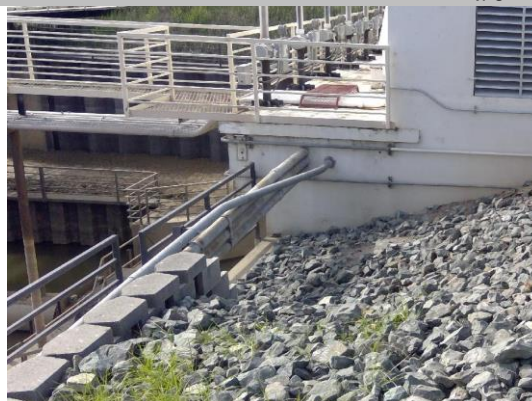
Photo 1 of 3 : UCIP_SP_2020_53974_79183.jpg

DS_ID:22961
 FS_ID:53974
 EP_NO: N/A
 Repair Type: Non-Urgent
 Crossing Status: Found
 UCIP Comments: 05/06/2019 No issues recorded during inspection.
 (O.Yakimov - DWR UCIP)
 FIELD_STRUCT_DESC: 2 of 4: 4-inch galvanized iron electrical conduit through the levee, 3.4 feet below the crown. Pipe runs from an electric vault on the landside (LS) shoulder to a building on the waterside (WS) shoulder.
 FS Date: 5/6/2019 2:56:10 PM

Closer view of conduits coming out of building

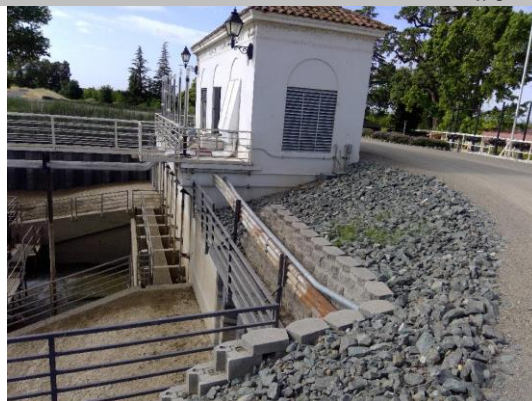
Photo 2 of 3 : UCIP_SP_2020_53974_79184.jpg

Four conduits crossing the levee. View of WS slope

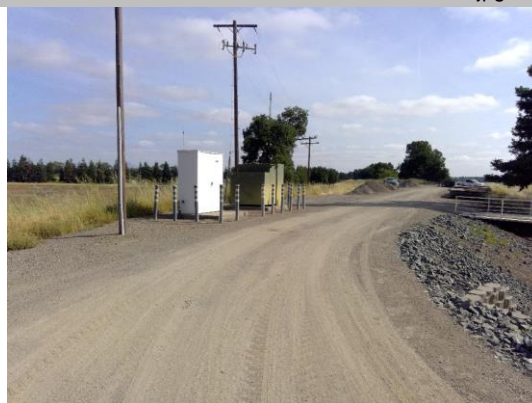
Photo 3 of 3 : UCIP_SP_2020_53974_79186.jpg

Top of Levee with electrical vaults on LS shoulder

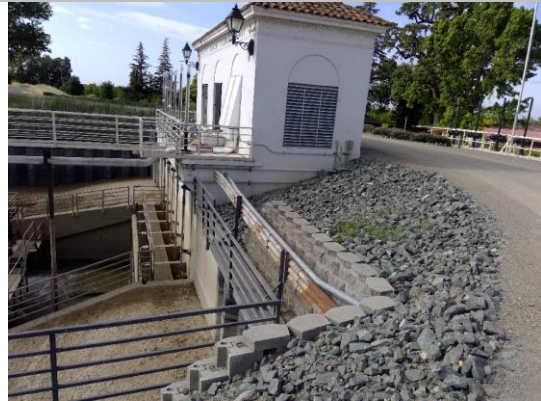
Photo 2 of 3 : UCIP_SP_2020_53976_79192.jpg

Four conduits crossing the levee. View of WS slope

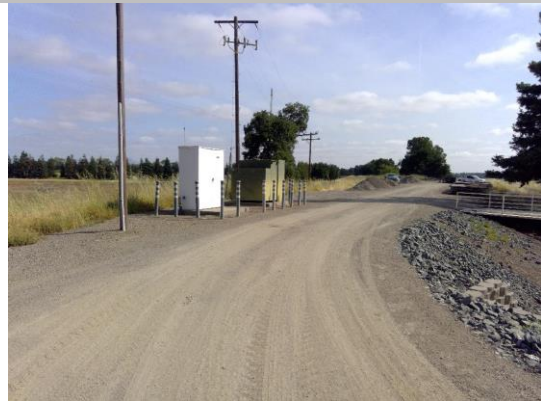
Photo 3 of 3 : UCIP_SP_2020_53976_79194.jpg

Top of Levee with electrical vaults on LS shoulder

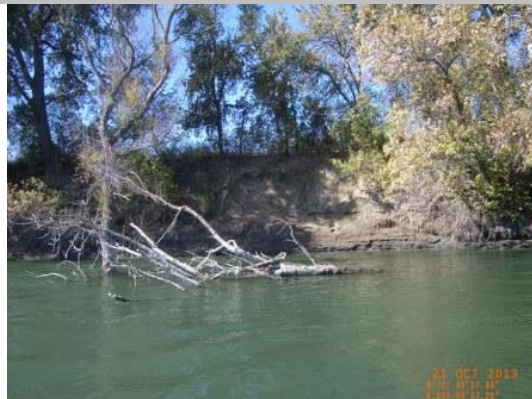
Photo 1 of 1 : SP_2020_NA0016_435_88_20200228_00021.jpg

LM Start	25.75	Rating **	A/W	Issue No.	88
LM End	25.91	Issue Type +	Ma	Location *	WS
Category	Supplemental			GPS Latitude/Longitude	
				Start	End
Item	2017 USACE Erosion Survey			39.014499 °	39.016401 °
				-121.825880 °	-121.824230 °
DWR ID	DWR_NA0016_01_f_2018_88				
Comment Code					
Inspector Comment					
2017 Site ID: SAC 118.0 R					
Status: Eroding					
2017 Field Notes: No observed change.					
Site History: 2008 - Whole bank is eroding, nearly vertical slope with cohesive toe. Bed is very deep along the toe (greater than 30 ft deep at 20 ft from the shore). 2011 - Some new minor erosion. 2016 - Minor new erosion.

USACE 2013 Photo #1

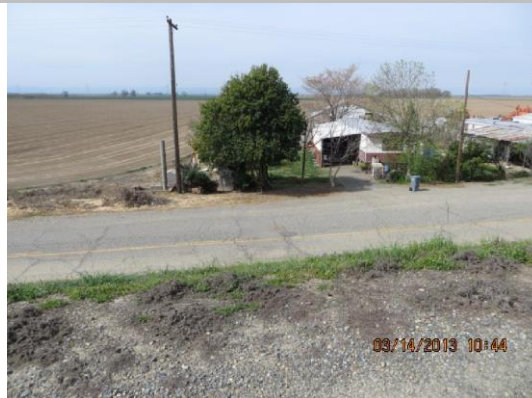
Photo 1 of 3 : UCIP_SP_2020_53977_17532.jpg

Comment Code					
Inspector Comment					
DS_ID:20253 FS_ID:53977 EP_NO: 9136 Repair Type: Non-Urgent Crossing Status: Found UCIP Comments: 05/06/2019 Unable to see pipe outlet at riverbank due to vegetation. Levee is in good condition at the crossing. (O.Yakimov - DWR UCIP) Pipe appears to be abandoned. Pipe needs to be abandoned properly. FIELD_STRUCT_DESC: *ABANDONED* 18-inch coated steel drainage pipe through the levee, 3 feet below the crown. Steel cutoff wall at the centerline. Air release valve on the waterside (WS) shoulder. Slide gate inside a 72-inch diameter corrugated metal riser unit on the landside (LS) toe. (Permit No. 9136, 1973 - Durst Brothers). [Additional Reference(s): DWR Levee Log, 2006]. FS Date: 5/6/2019 3:43:56 PM

72-inch CMP riser on LS toe under JP next to tree.

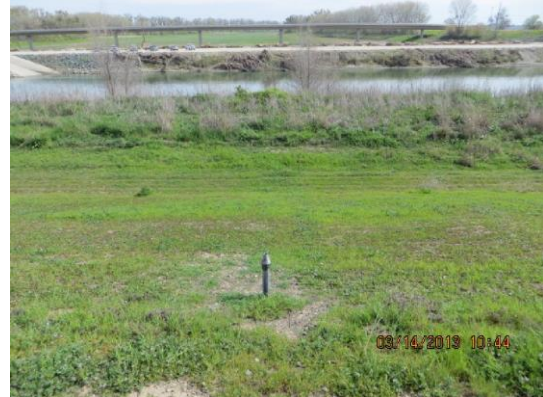
Photo 2 of 3 : UCIP_SP_2020_53977_17531.jpg

Air release valve on WS shoulder.

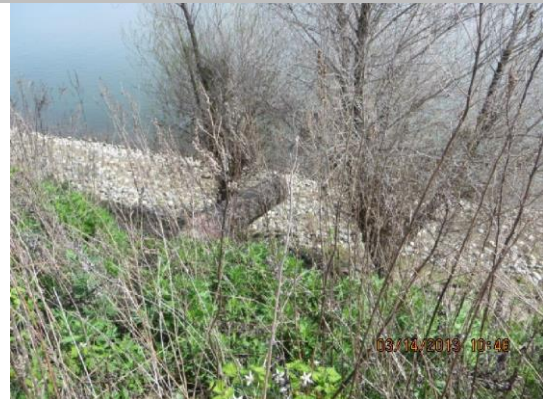
Photo 3 of 3 : UCIP_SP_2020_53977_17534.jpg

Pipe at Rivers edge.

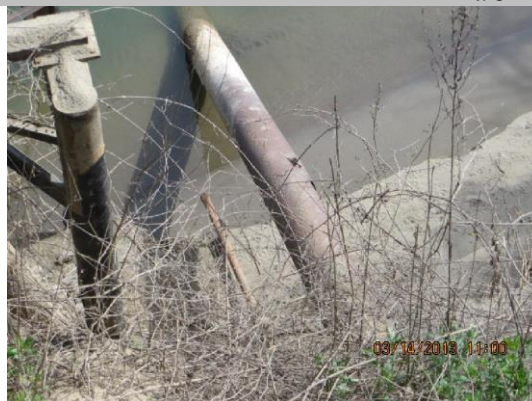
Photo 1 of 3 : UCIP_SP_2020_56073_17538.jpg

Comment Code					
Inspector Comment					
DS_ID:20254 FS_ID:56073 EP_NO: 9371 Repair Type: Non-Urgent Crossing Status: Found UCIP Comments: 10/01/2019 Pipe is not found on LS. Open pipe end is visible in concrete sump at riverbank. Pipe that was coming out from sump towards levee has been removed and its hole in sump was immured. (O.Yakimov - DWR UCIP) FIELD_STRUCT_DESC: *ABANDONED* 1 of 2: 14-inch steel irrigation pipe through the levee, 4.5 feet below the crown. Slant pump on steel structure on the waterside (WS) bank. Screw gate at pump to divert water into concrete sump on the WS berm. Concrete tank on the landside (LS) across the county road. Steel plate bolted on the WS end. (two 14-inch pipes, at different depths, authorized under Automatic Board Order (ABO) issued as Permit No. 9371, 1974 - Fred, Lloyd, and Beverly Durst; 14-inch pipe grouted in place in 2000 under PN 9371 as per permit notes). [Additional Reference(s): DWR Levee Log, 2006. USACE Sacramento O&M Manual 131, May 1960 (HLM 26.92), one 14-inch pipe referenced]. FS Date: 10/1/2019 2:58:00 PM

Pipe visible at waters edge.

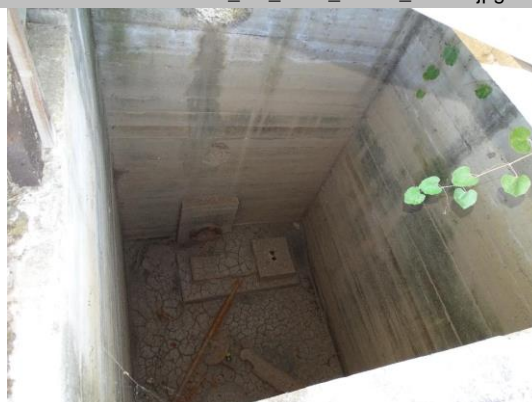
Photo 2 of 3 : UCIP_SP_2020_56073_83207.jpg

Open pipe in concrete sump coming from riverbank

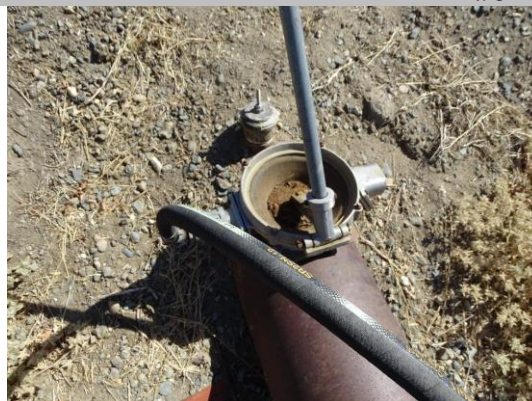
Photo 2 of 3 : UCIP_SP_2020_56074_83211.jpg

Hand pump on LS shoulder

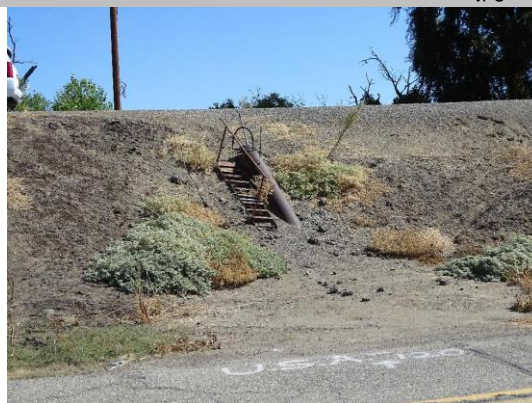
Photo 3 of 3 : UCIP_SP_2020_56074_83210.jpg

LS levee slope

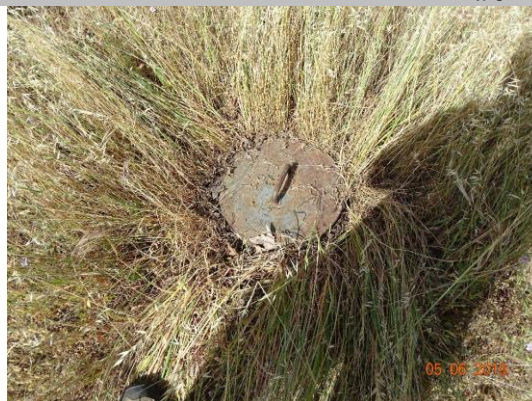
Photo 1 of 3 : UCIP_SP_2020_53978_79198.jpg

Comment Code						
Inspector Comment						
DS_ID:20255 FS_ID:53978 EP_NO: 4786 Repair Type: Non-Urgent Crossing Status: Found UCIP Comments: 05/06/2019 Crossing not in use and looks abandoned. Air release valve is silted inside a riser on WS shoulder (O.Yakimov - DWR UCIP) FIELD_STRUCT_DESC: 16-inch steel drainage pipe through the levee, 6.2 feet below the crown. One metal cutoff wall. Gate valve on the landside (LS) end. Siphon breaker on the waterside (WS) slope inside steel riser unit. Flap gate on the WS end. Bank rock revetted. (Permit No. 4786, 1964 - F. Erdman). [Additional Reference(s): DWR Levee Log, 2006]. FS Date: 5/6/2019 4:11:08 PM

View of covered metal riser on WS shoulder
